CITY OF SIOUX FALLS
FALLS PARK, SOUTH DAKOTA
DECEMBER 10, 2018

VISIT DATE	October 29, 2018
CONTACT/TITLE	Karen Leonard, Deputy City Attorney
LOCATION VISITED	Falls Park in Sioux Falls, South Dakota

My primary objective was to visit Falls Park located in Sioux Falls, South Dakota and provide an independent review of the drowning risk associated with Big Sioux River and Falls which pass through the park.

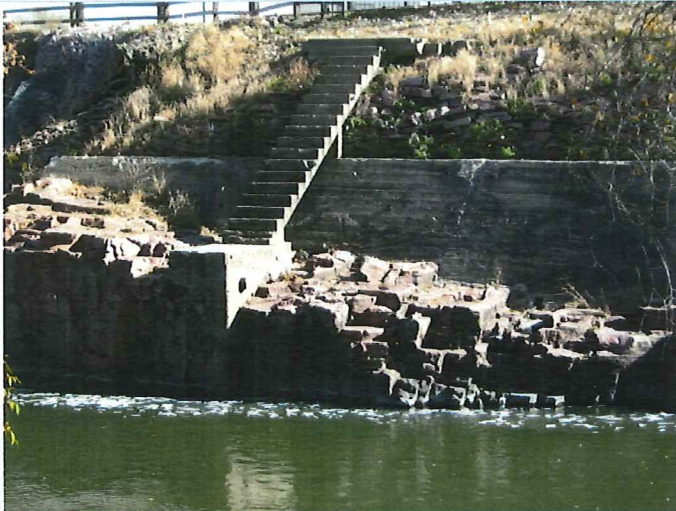
Pic #1

This area represents a potential "attractive nuisance to Falls Café patrons and the existing wooden fence appears to be easily by-passed by adults, minors, and young children.

Stairs (historical) just North of Low Head Dam, East bank of river

2018-3	<p>Extend the metal vertical guard railing beyond its current point to further mitigate access to the area along the East bank of the river, which includes the single set of concrete stairs that are North of the low head dam. These stairs were indicated to have historical significance.</p>

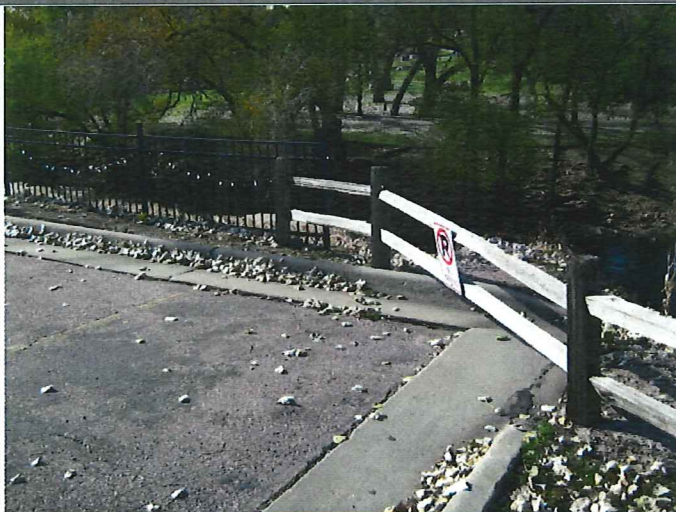
Pic #3

Fencing by Stairs, East side of River

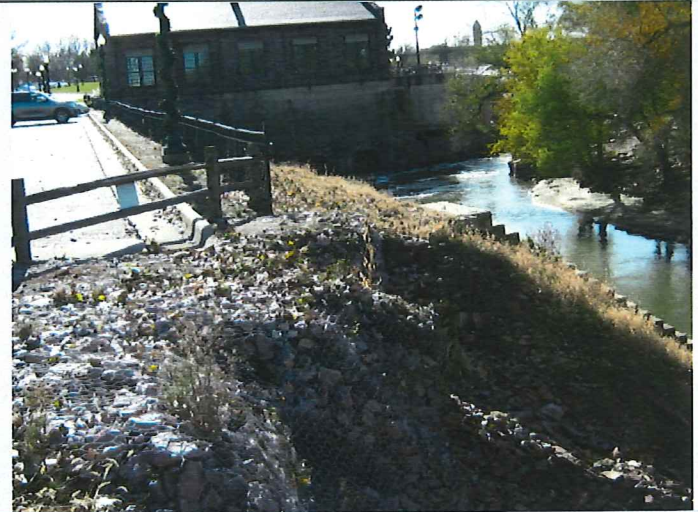
Pic #4

Fencing by Stairs, East side of River

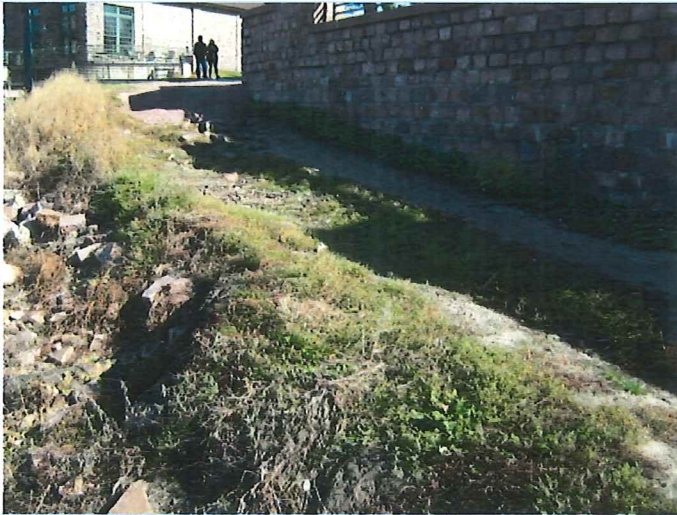
Pic #5

Path leading down to slippery rocks, East bank of river

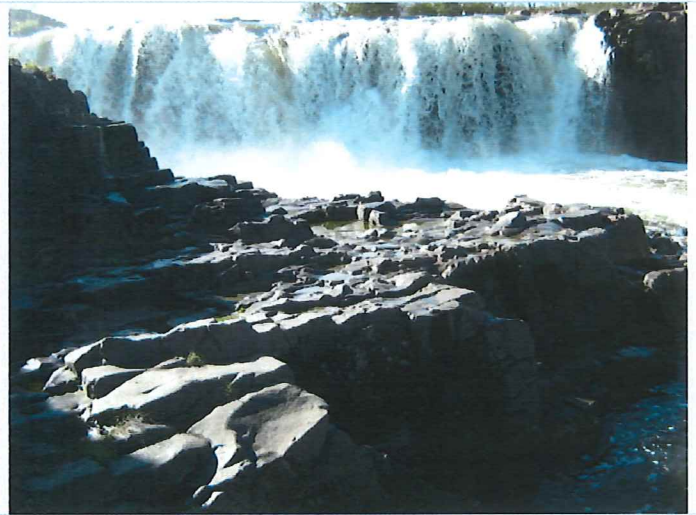
Pic #6

Slippery Rocks, East bank of River

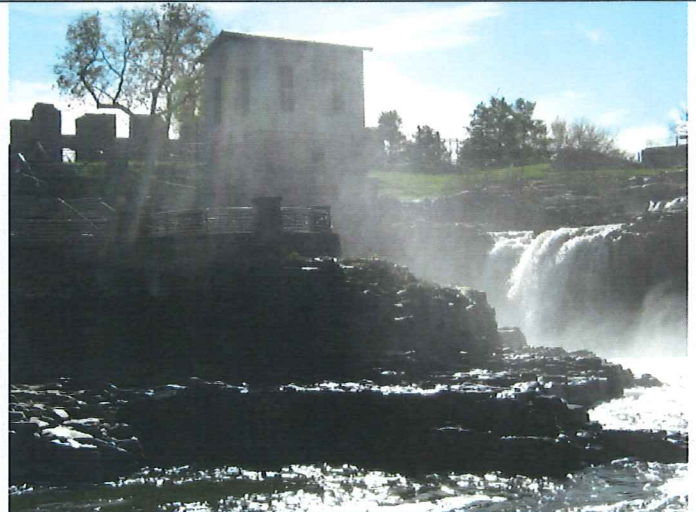
Pic #8

Slippery rocks past sandy path, East bank of river

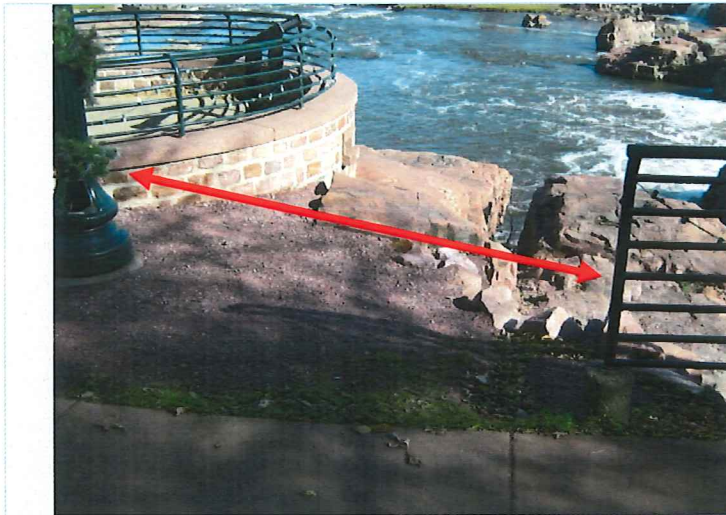
Pic #9

Gap between existing railing and platform, West bank of River

Rec #	Recommendation Details
2018-1	<p>Consider making the sandy path along the East river bank less accessible to visitors.</p> <p>This sandy path allows easy access to a large grouping of river rocks made slippery from the mist of the falls. The path was observed to be frequently traveled by visitors, even though a viewing platform was readily available in the immediate vicinity.</p> <p>Possible solutions could include extending the existing metal guard railing, or positioning large boulders or other natural barriers to maintain the park aesthetics while still providing a safeguard to this area.</p> <p>Reference pictures below #5-8</p>
2018-2	<p>Further eliminate access to the rock formation that juts out into the river from the existing viewing platform to reduce the possibility of visitors slipping and falling from potential moisture caused by rain, sleet, or snowfall combined with the steep angle of the rock formation.</p> <p>This could be accomplished by extending the existing guard railing to close the gap between railing and the viewing platform. The rock formation and viewing platform are located on the West bank of the river.</p> <p>Reference pictures below # 9-10</p>

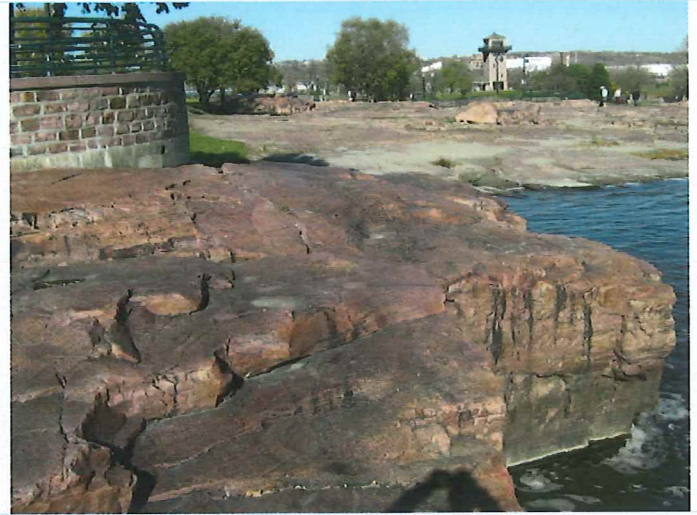
Pic #10

Rocks beyond gap between railing and platform, West bank of River
